ENGINEERING CASE LIBRARY

## THE FULMINATING FIRE EXTINGUISHER (A)

This case history relates the chain of events leading to the "explosion" of a stainless steel fire extinguisher which severely injured the individual handling it at the time. Investigation into the cause of the accident was necessary since the injured party entered suit. Before settlement was reached, five defendants were involved.

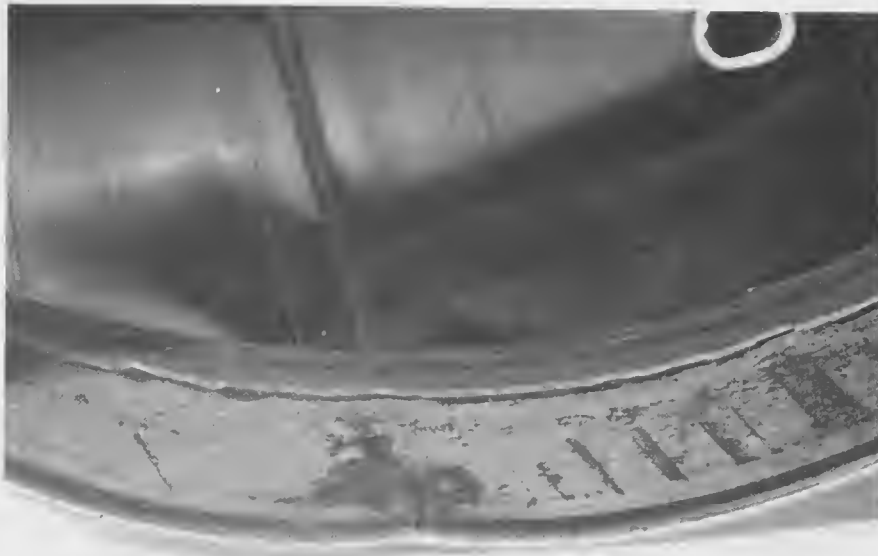
Fig. 1

Figure 1 shows a section of the bottom end of the failed extinguisher. A longitudinal and a circumferential weld are obvious. It was reported that the extinguisher was fabricated from stainless steel. The barrel of the extinguisher was, no doubt, fabricated by forming a flat rectangular sheet into a cylinder with joining accomplished by welding. The end was closed by welding in a "dish" which was formed by pressing or drawing a flat sheet disc into the desired form. The failure surface is equally obvious. There is also an obvious difference in the appearance of the inner surface of the barrel between the portion which contained the dry chemical and the "skirt" which provided a stable base for the extinguisher. The "skirt" portion is obviously covered with a "flaky", "puffy" material while the inner portion of the barrel is quite clean and shiny.

Section of bottom end of fire extinguisher. The longitudinal and circumferential weld beads are obvious. The fracture edge can be seen. The difference in appearance between the clean interior and the "coated" skirt is obvious.

The appearance of both the longitudinal and circumferential welds as well as the distance of the actual fracture from the welds, more than 1.25 cm (1/2 in), indicates that the welds did not contribute to the failure.

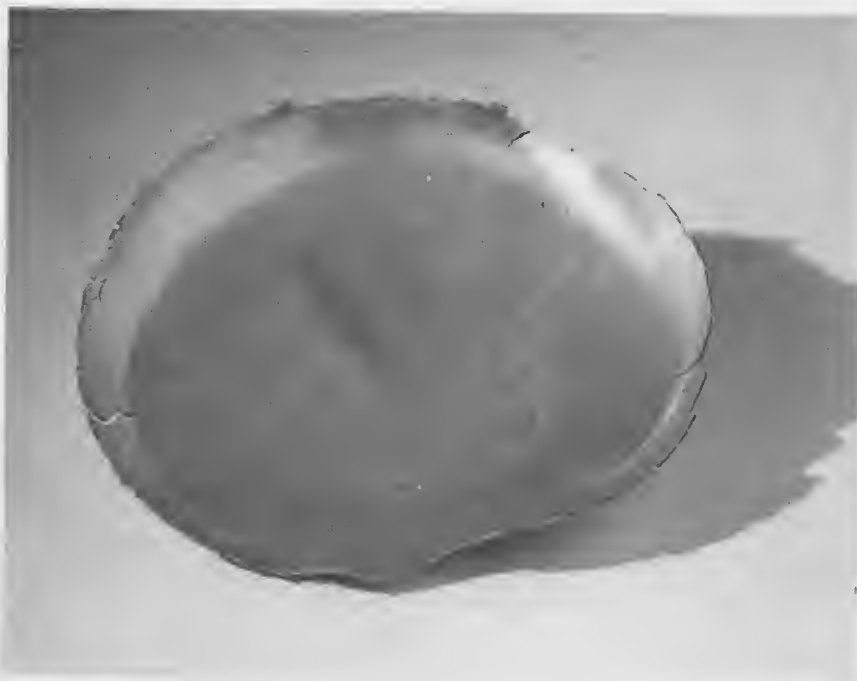
Fig. 2

Figure 2 shows the inside surface of the entire "dished" end, which is relatively clean and shiny. Several cracks and ruptures, as well as the fractured edge, are clearly visible.

Inside surface of "dished" end of fire extinguisher. Several cracks are obvious.

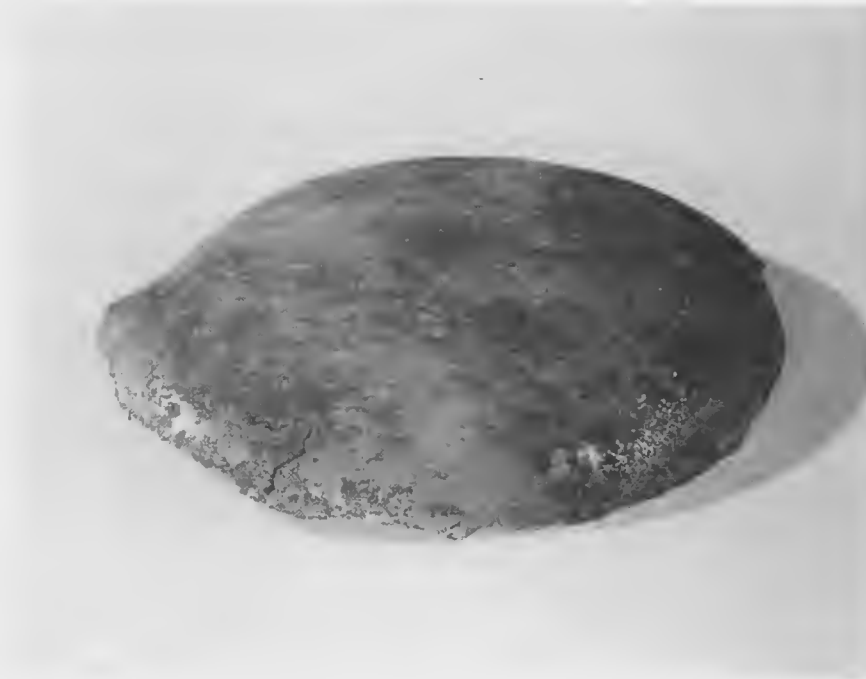
Fig. 3

Figure 3 shows the outside surface of the "dished" end, which obviously is not clean and shiny. This surface is rather thoroughly covered by a deposit which is brownish in color and appears to be the same as the deposit on the "skirt" which is obvious in Fig. 1.

Outside surface of "dished" end of fire extinguisher. There are obvious deposits of material which are not seen on the inside surface. Some cracks are obvious.

Spectrographic analysis indicated that the material in the "dished" end was either Type 302 or Type 304 stainless steel. Wet chemical analysis was not performed since the hypothesis applies equally well to either type. Spectrographic analysis of the deposit on the outside of the "dished" end indicated the presence of calcium.

There was no conclusive evidence of chlorine as spectrographic analysis will not detect chlorine. The presence of calcium in the deposit on the "dished" end was strongly suggestive. The jeep which carried this fire extinguisher was used for perimeter patrol plus various miscellaneous duties by the plant guard force. It was highly likely that one such duty would be to transport calcium chloride to be spread on icy steps and sidewalks in winter weather. The extinguisher sat in a "well" in the jeep. It is very probable that moisture could collect in this well, at least periodically. A combination of calcium chloride with moisture in a relatively confined space would almost certainly lead to corrosion of a susceptible Type 302 or Type 304 stainless steel. (The use of  $\text{CaCl}_2$  was later confirmed during deposition of a witness.)

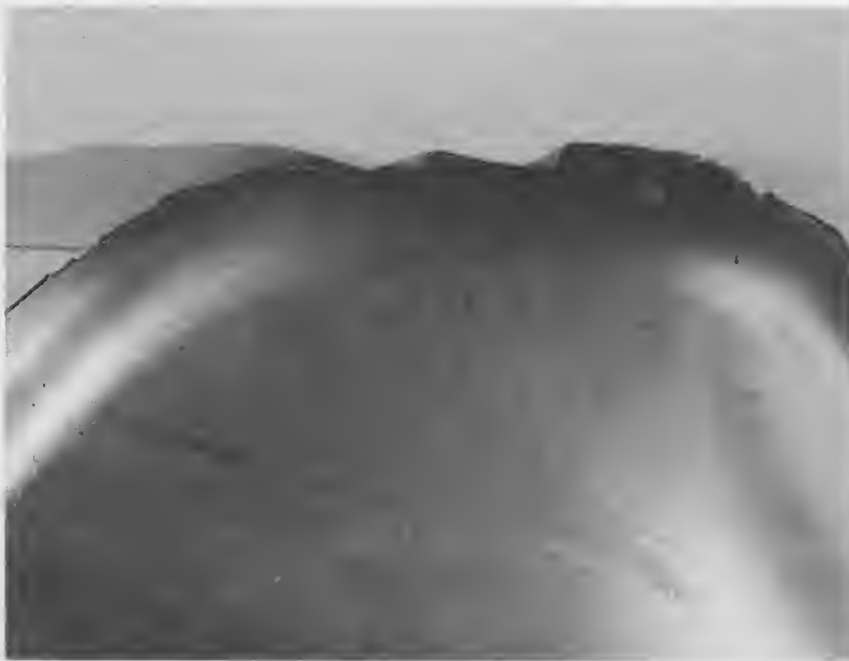
Fig. 4

Figure 4 shows a "head-on" view of the crack shown at the right of Fig. 2. Figure 5 shows a "head-on" view of the cracks shown at the left of Fig. 2.

"Head-on" view of cracks as seen on the inside surface of the "dished" end (right side of Fig. 2).

In examining Figs. 4 and 5, it is obvious that the cracks are not straight, but "zig-zag", indicating that the cracks follow along boundaries between individual grains rather than passing through the grains. Thus the cracks are intergranular, not transgranular.

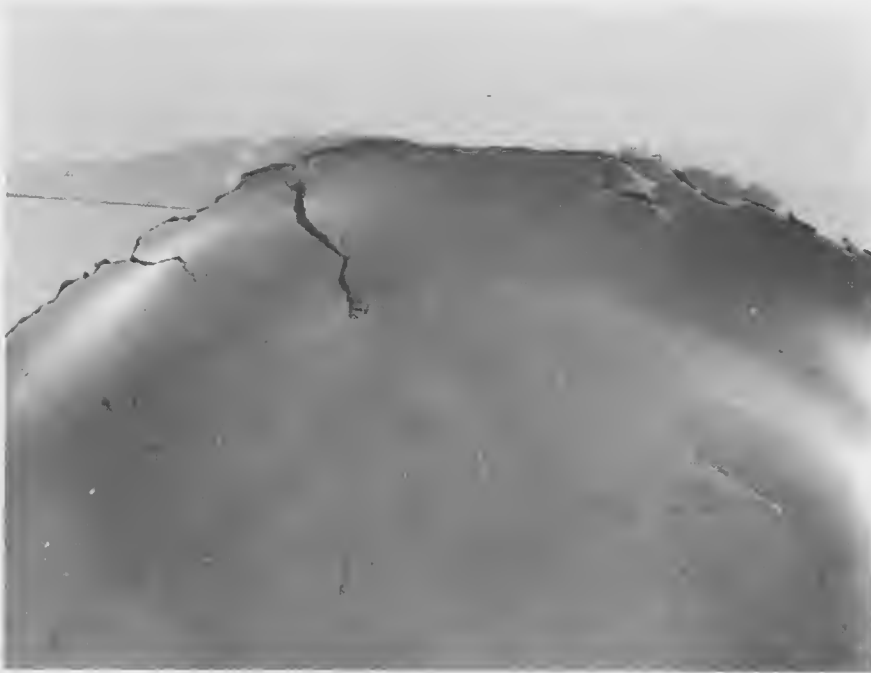
Fig. 5

"Head-on" view of cracks as seen on the inside surface of the "dished" end (left side of Fig. 2).

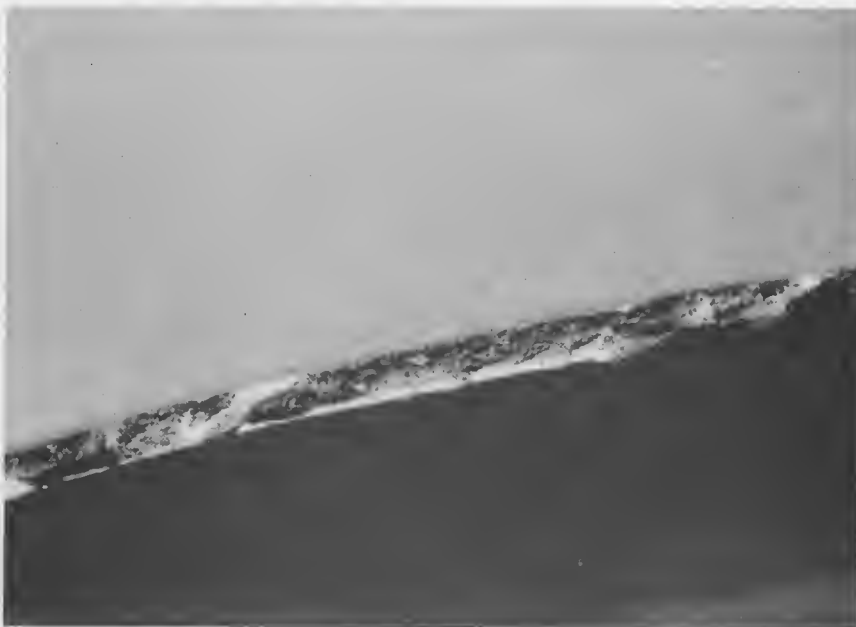
Figure 6 shows a typical region of the failure edge of the "dished" end. The darker regions of this fracture surface were colored with variations and mixtures of reddish-brown and bluish-grey.

Typical portion of failure edge of "dished" end. Contrast between light and dark areas is obvious.

The appearance of Fig. 6 with reddish-brown and bluish-grey regions in contrast with some bright and shiny areas indicates that there was partial failure of the metal prior to the accident. In other words, the colored regions had failed earlier so that only part of the metal (that appearing light in color) was still intact to support the discharge pressure.

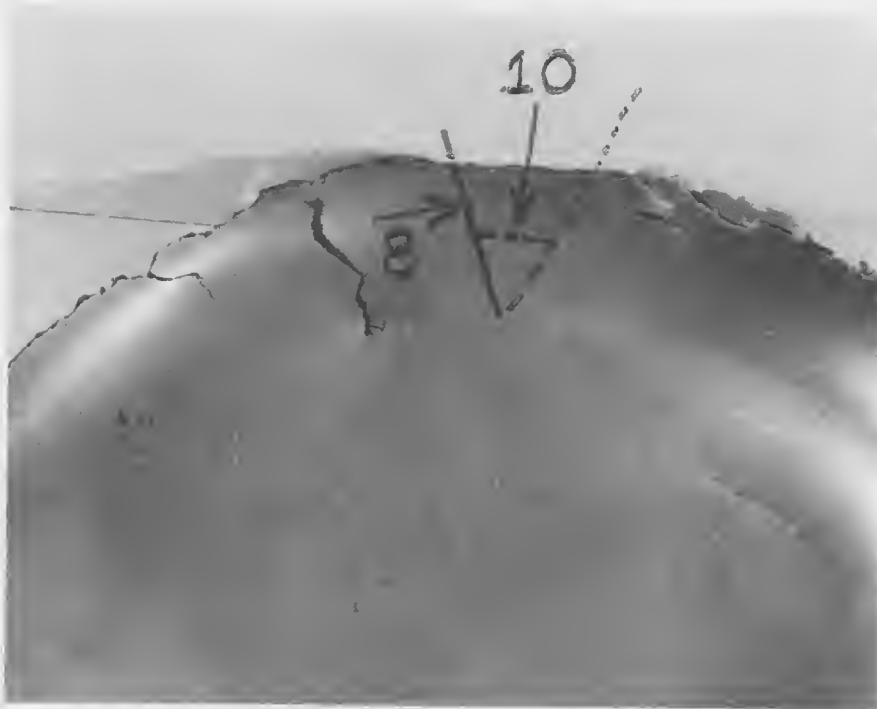
Fig. 7 shows the same portion of the "dished" end as Fig. 5 but with an indication of where sections were taken for metallographic examination and the direction of viewing the specimens taken.

Cracks as viewed in Fig. 5. Locations of photo-micrographs and directions of viewing are indicated.

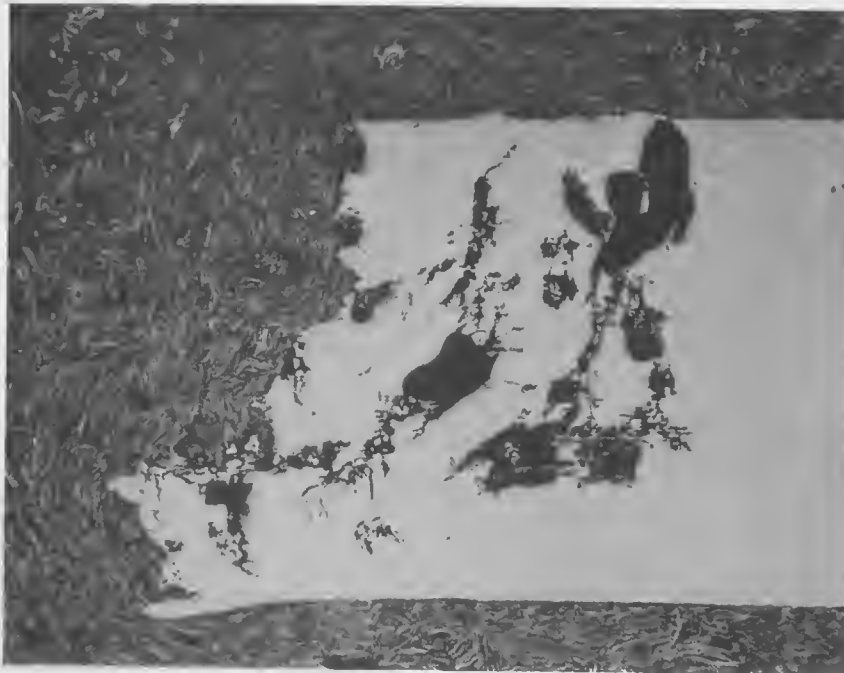
Fig. 8 is a photomicrograph of a radial section of the "dished" end in the approximate location shown in Fig. 7. This figure clearly shows the intergranular nature of the fracture (left side of photograph) and penetration into much of the nearby material. Figure 9 is the same section as Fig. 8 after etching. A partial network along the grain boundaries is obvious. Figure 10 is a tangential section of the "dished" end in the approximate location shown in Fig. 7. The grain boundary network is also obvious in this photograph, indicating the network was rather widespread.

Radial section of "dished" end at failure surface. Failure is obviously along grain boundaries. Penetration of corrosion into material near failure surface is apparent.

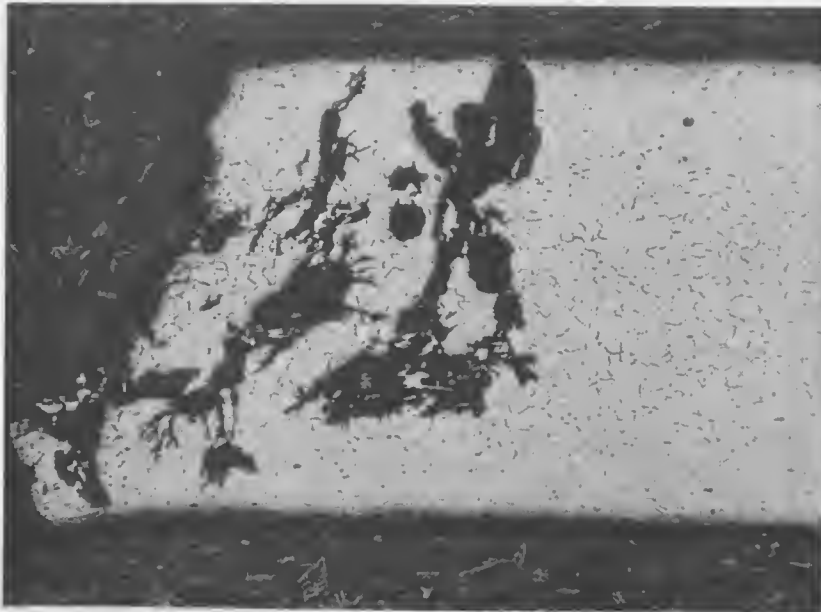
Fig. 9

It is almost certain that the network around the grain boundaries was present in the stainless steel sheet when the extinguisher was fabricated, as there is no way in which it could develop during the fabrication. This network is probably a chromium carbide (or a complex chromium-iron carbide). This could have been removed before fabricating the extinguisher by heating to about 2000°F and quenching the sheet in water. This carbide network is highly significant since the grains in the immediate vicinity of the grain boundaries are locally depleted in chromium thereby becoming highly susceptible to various corrosive agents, especially chlorine. Chromium in stainless steel provides corrosion protection only when in solution but not when combined with other chemical elements such as carbon.

Radial section of "dished" end of failure surface. A partial network around the grains, i.e., along the grain boundaries, is apparent

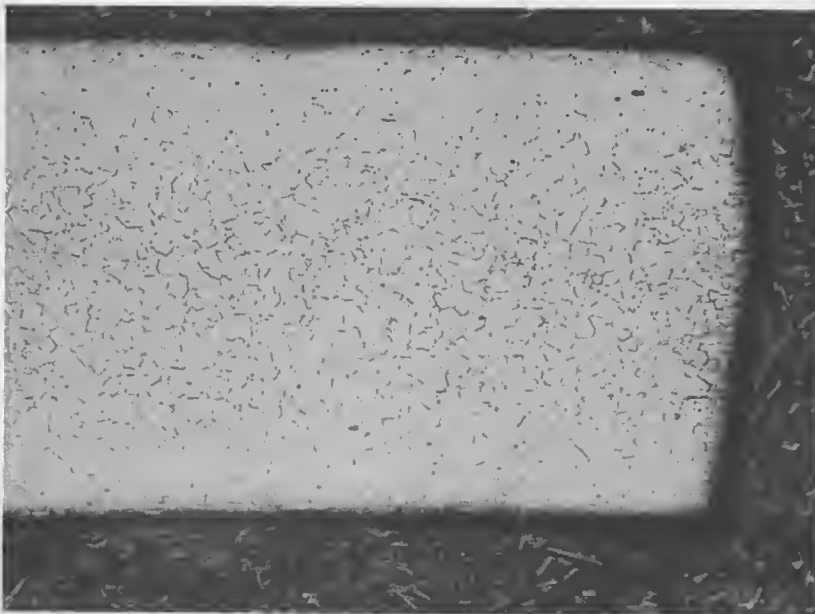
Fig. 10

Circumferential section at some distance inward radially from the failure edge. The presence of the grain boundary network is evidence of a widespread network.

Failure in this fire extinguisher was due to a rather unusual set of circumstances. At the same time, one could argue that this was foreseeable. If you were the manufacturer, what would you now do? Would you avoid the potential problem by heat treating to remove the grain boundary network, by using extra low carbon stainless steel (e.g., Type 304L), or by using a stainless steel having an alloy addition with which carbon forms a more stable carbide than it does with chromium, e.g., Type 347?
